Hume Township

Electrical System Health Check

October 18, 2019

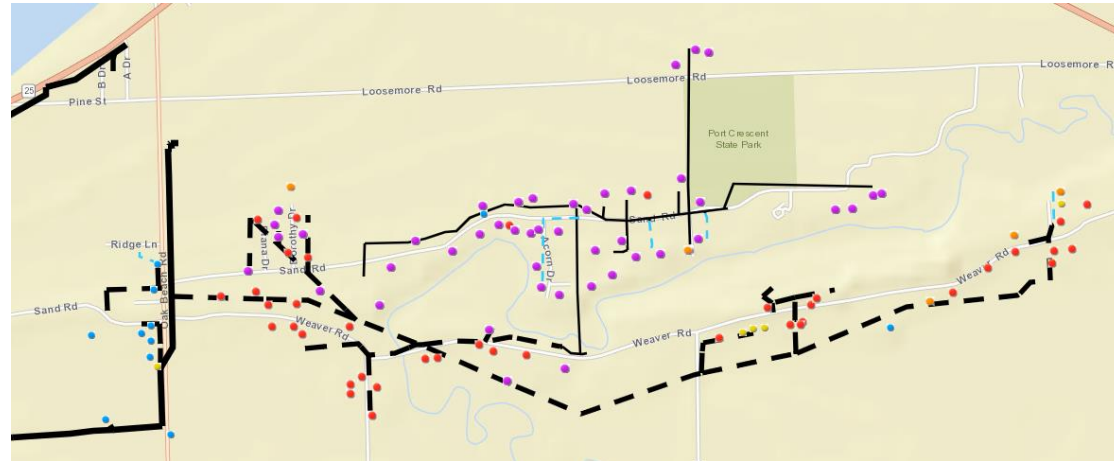
Area 1: OAKBH0302

Weaver Road, East of Oak Beach Road

2018 Sustained Outages: 5

2019 Sustained Outages: 11

Cause of 2019 Outages:

- Most outages caused by tree interference during storm and down power lines due to tree interference/wind.

Tree Trimming	Last completed in 2012
Infrastructure Resilience	Aging equipment was identified and replaced on OAKBH0302 in Q3 2019
Preventative Maintenance	Maintenance work was completed at OAKBH substation in 2019
